Preventing failures in ring tanks

By Jim Purcell, Aquatech Consulting Pty Ltd, Narrabri and Warren

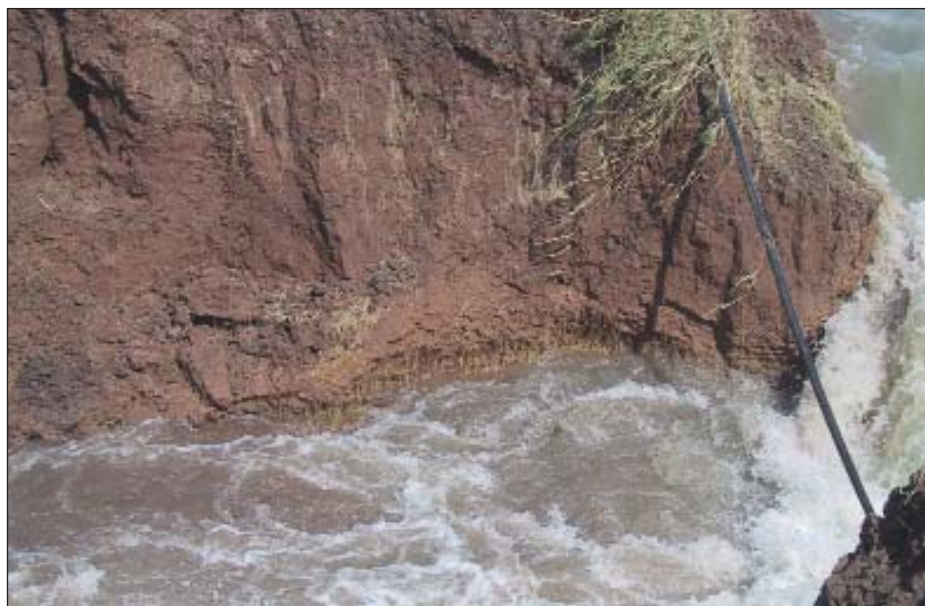
3.45pm: The early stages of a break in a storage wall — note the grass roots right through the embankment and the dripline for irrigating grass.

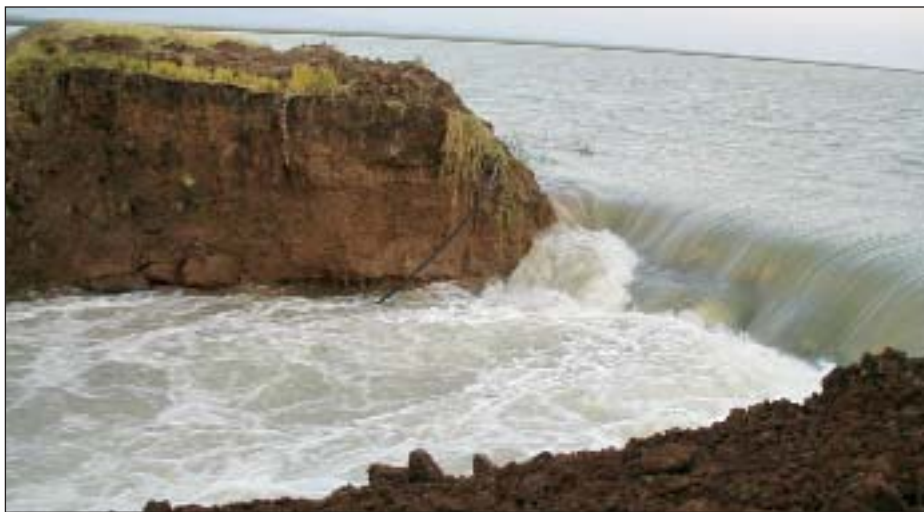
5.20pm: Once the water starts flowing through cracks, failure is quick and hard to stop.

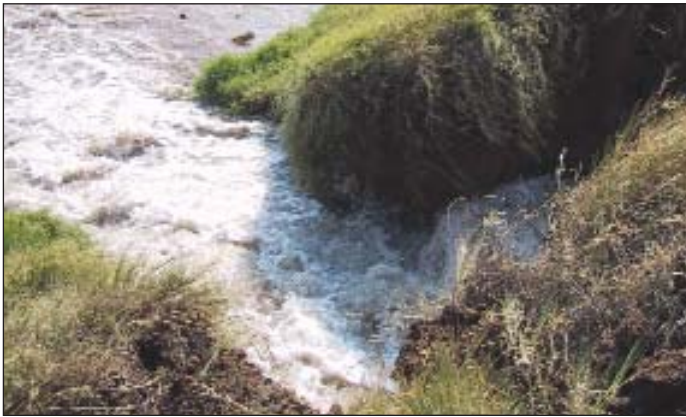
Grass on outside batter also growing into embankment with cracks coming from both sides.

Anybody who suspects that their embankment may have these characteristics should take action now. Any grass on the crest or outside batters should be removed and the bank carefully inspected for erosion rills (cuts) or cracks.

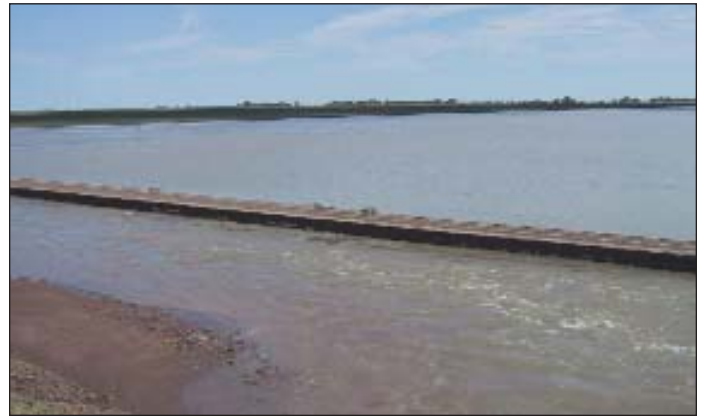
Physical damage outside the embankment is generally relatively small but crop damage from water can be a problem.

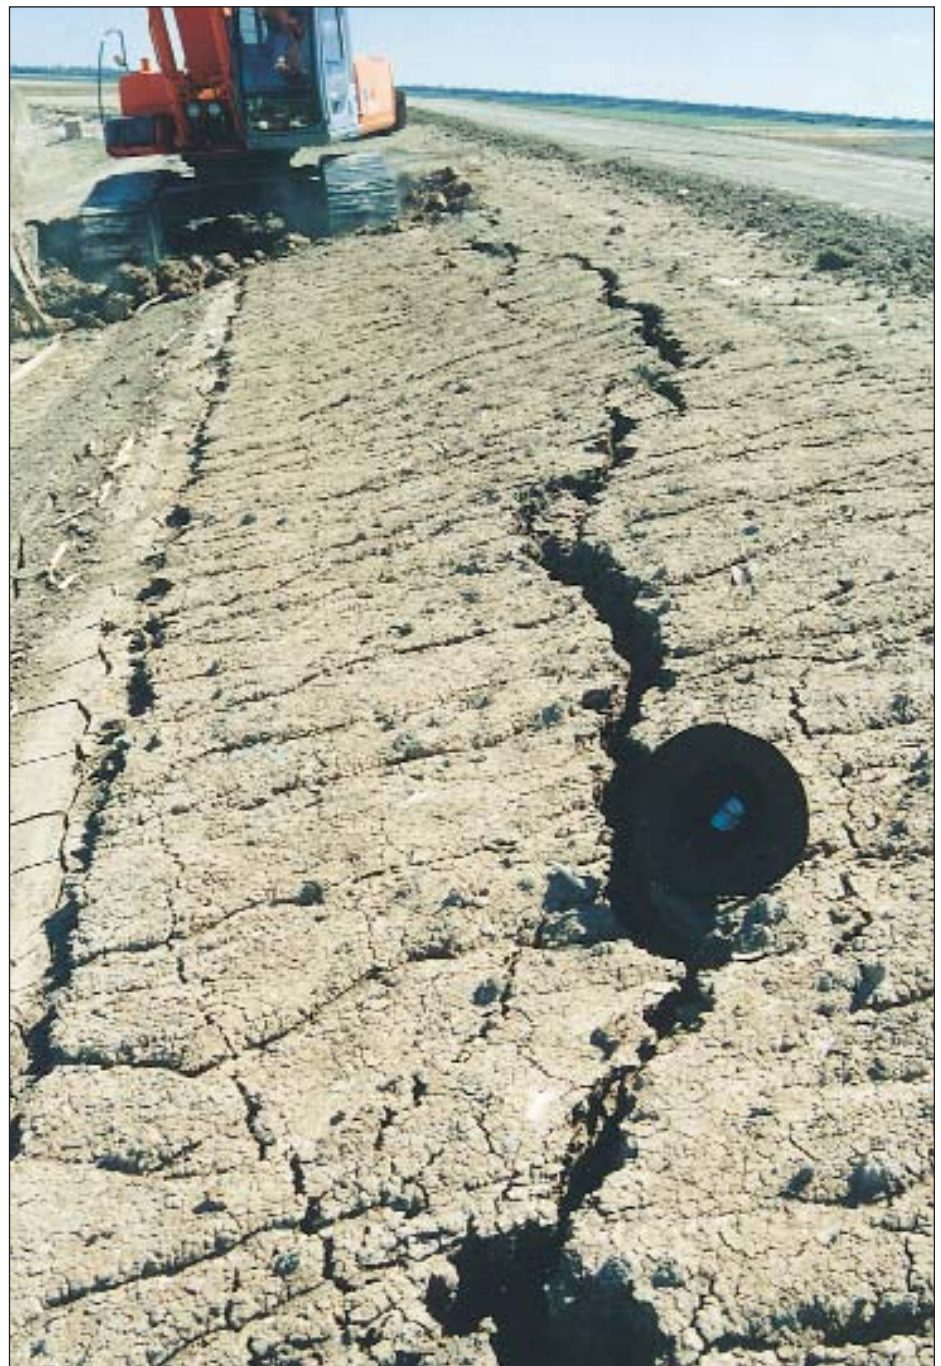
Settlement on inside batter from initial fill caused poor compaction with dry material.

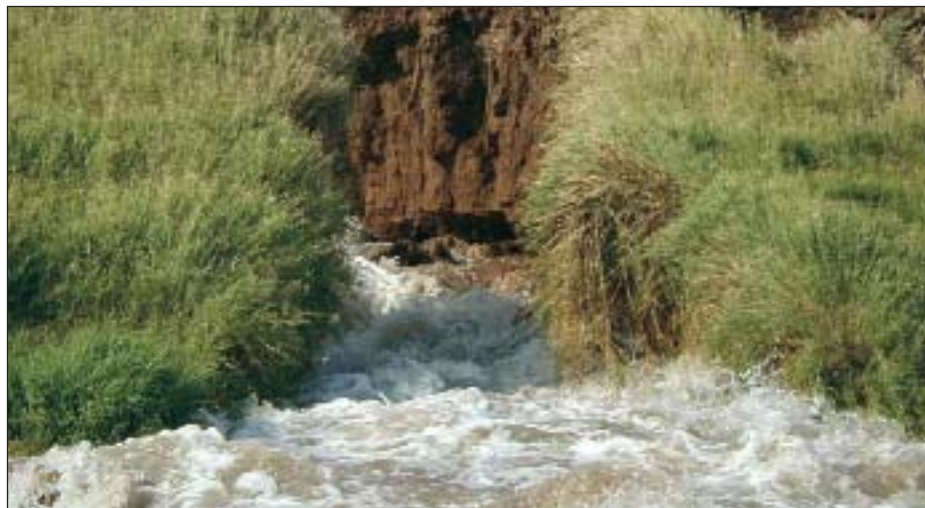
Some of these grasses have been aggressive tropical varieties like African Star Grass which is good in water and offers good batter protection but will not become dormant in drought like native grasses. These grasses continue to drive roots deeper into the embankment to source moisture for survival. As the grass depletes the moisture, the clay in the bank shrinks and cracks into a block structure.

This process continues and the grass roots go further into the bank and so do the cracks. This sometimes happens under the cover of the grass and is not visible on the surface.

Vigorous grass over the whole embankment. Note cracked blocking structure in the embankment from grass roots.

To stop this process the cracks must be repaired to prevent a continuous path through the embankment. In the worst case, the top section of the embankment has to be rebuilt using the same material but reworked, laid in thin layers, moistened and compacted.

If the cracking is not as bad, a core in the water side of the crest could be rebuilt with an excavator. Again ensure it is rebuilt

by placing moist, thin layers and rolling with a sheepsfoot roller attachment on the excavator boom until the roller rides up on top of the layer.

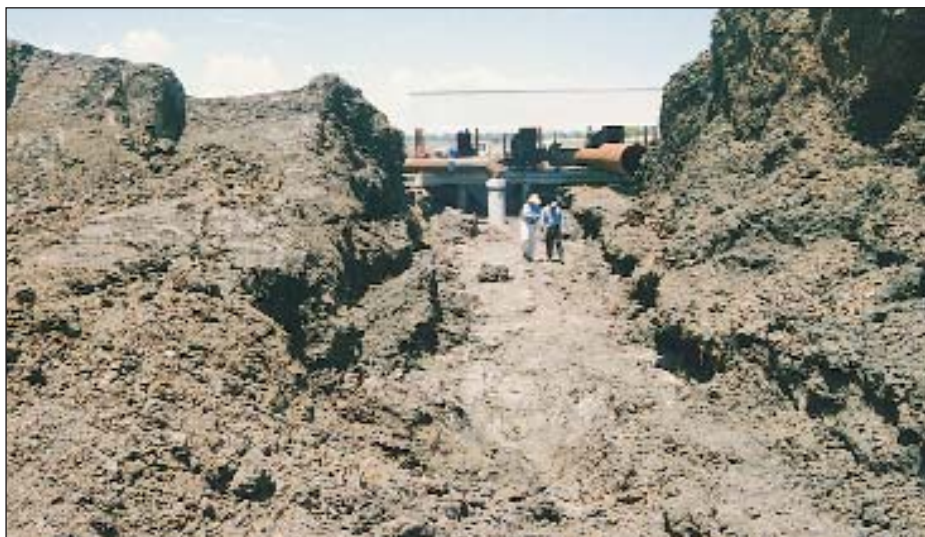
Bank failure along top of pipe through embankment to pumping station. Special care is needed when compacting around pipe. Cut-off collars, preferably flexible, should be installed around pipe
